# 2020 Deep Creek Lake Hydrilla Management Plan and Report of Control Activity

Prepared by Julie Bortz

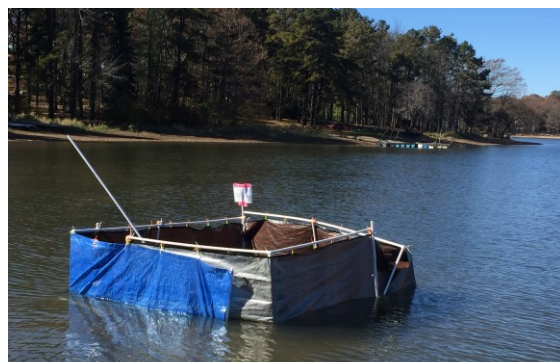
Figure 3: picture of tarp and PVC enclosure erected around newly discovered hydrilla bed

Should any hydrilla observed in the treatment zones appear to be resistant to the systemic herbicide or any areas be found with newly discovered hydrilla, “spot treatments” using a contact herbicide would be considered. Regular scouting throughout the lake’s coves and shallow water shorelines would also be conducted during the hydrilla growing season. Scouting would be done visually from the surface of a boat or underwater surveys using SCUBA or mask and snorkel would be conducted in targeted areas outside the treatment zones as resources allowed. If a new bed of hydrilla was found outside the treatment area or plants remained viable after the block treatment, a “spot treatment,” would be planned for the area. Spot treatments would be done using a contact herbicide, and a tarp/PVC enclosure (see Figure 3) would be erected prior to treatment around the area, if conditions allowed. This enclosure would help to target the effects of the contact herbicide to the area enclosed as contact herbicides tend to be broad spectrum

and only impact plants that come in direct contact with the compound (Netherland, 2009). The enclosure would be taken down as soon as plants were no longer viable at the location and/or lake conditions warranted the removal. Spot treatments would be conducted as soon as possible following the discovery of a new patch of hydrilla or if hydrilla within a treatment zone appeared to not be affected by the herbicide. If a new patch of hydrilla was discovered outside the treatment zone, it would be included in the following years “block treatment” plan.
